Stucco Check Inspections, LLC

## Invasive Stucco Inspection

August 14, 2026

## Front Elevation Moisture Analysis

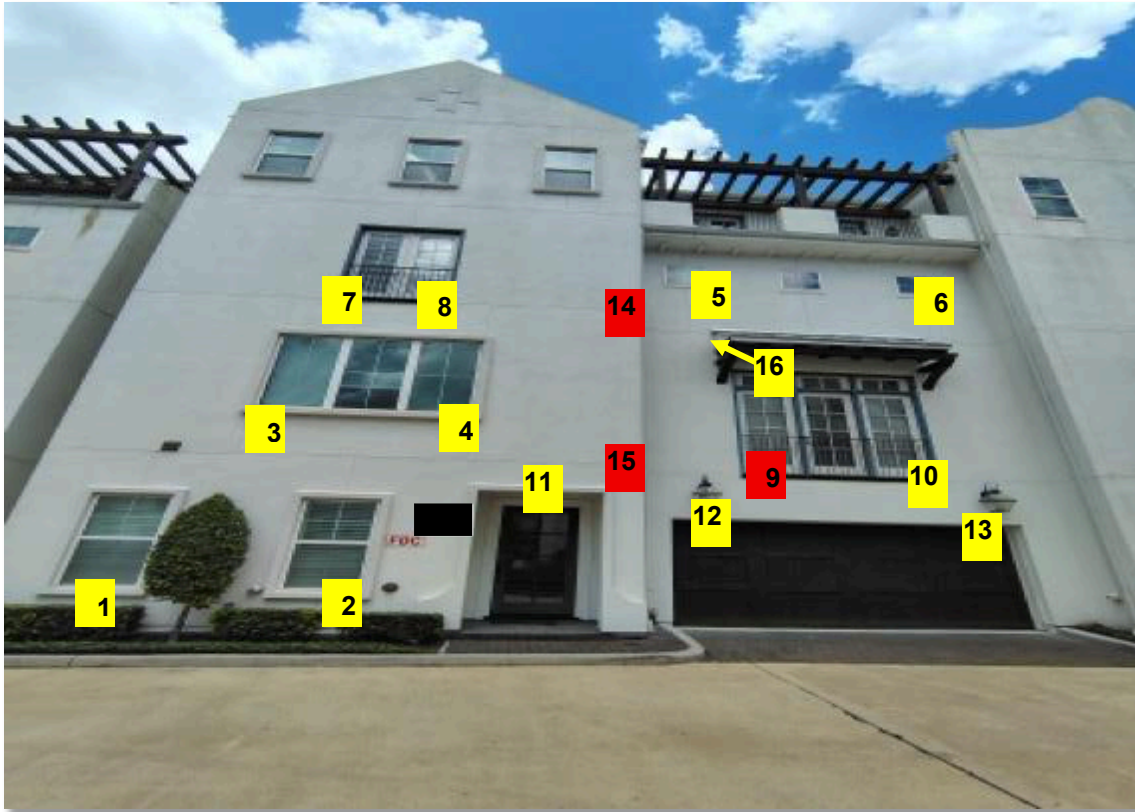
| Location | Moisture Reading | Substrate Condition | Comments |
|---|---|---|---|
| 1 | 14% | Firm | Probes 1-6 taken below the front elevation windows.<br><br>Firm substrate/framing and Low-mid moisture noted at the probed locations at the at the time of inspection. This is a favorable/fair condition. |
| 7 | 15% | Firm | Probes 7-10 taken below the corners of the Juliet balcony junctions.<br><br>Probes penetrated approx 1 ¼" beyond the ¾" stucco and elevated moisture. This is an indication of underlying damages (Noted as semi-soft) at probe 9. It is usggested to further investigate the areas by opening a core sample to determine the source and extent of damages. See summary for suggested protocol. |
| 11 | 10% | Firm | Probes 11-13 taken below the front elevation overhang.<br><br>Firm substrate/framing and Low moisture noted at the probed locations at the at the time of inspection. This is a favorable condition. |
| 14 | * | Semi-Soft | Probes 14-16 taken along the corner bead.<br><br>Soft substrate and possible framing (underlying damages) at probe locations 14-15. It is suggested to open a core sample to further investigate the source and extent of damages. Once exposed, damages may extend beyond the tested location. See summary for suggested protocol. |

- **Front/Juliet Balcony– Further Investigation Recommended:** Soft substrate and possible framing (underlying damages) at front probe location 9. It is suggested to open a core sample to further investigate the source and extent of damages. Once exposed, damages may extend beyond the tested location. See summary for suggested protocol.

- **Front Corner Bead– Further Investigation Recommended:** Soft substrate and possible framing (underlying damages) at left probe locations 14-15. It is suggested to open a core sample to further investigate the source and extent of damages. Once exposed, damages may extend beyond the tested location. See summary for suggested protocol.

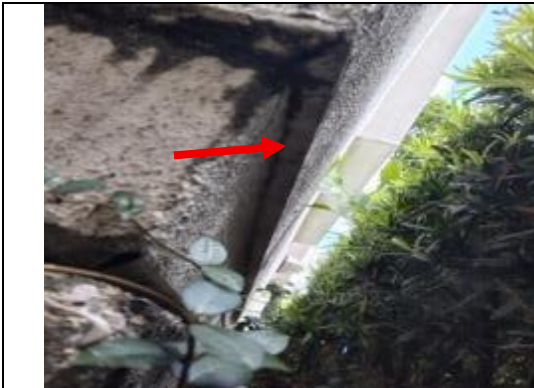
The stucco walls terminate with a weep screed flush with the foundation with little to no clearance or drainage gap. This can lead to trapped moisture and underlying damages. (No apparent issues found at the time of inspection.) All terminations should have a weep screed with a proper 2-4-inch clearance from grade or any paved areas). See the balconies form example.

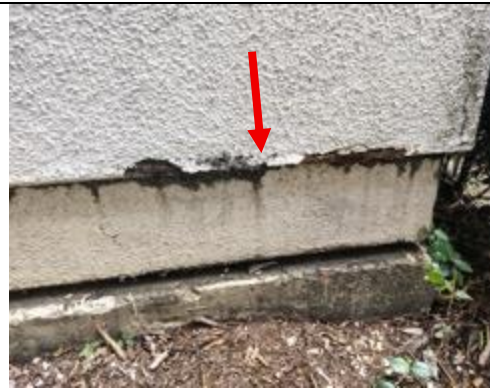
Rust noted at the base of the wall termination This is due to the weep screed being flush with this foundation. It is suggested to repair accordingly.

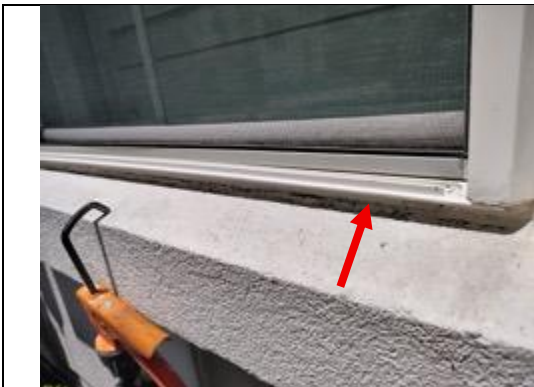
The sealant application that was previously done has reached/exceeded their life expectancy. It is suggested to remove the existing sealants and replace/ reseal all windows, accent bands, cracks, flashings, and penetrations at this time and, routinely, every 2-3 years.

**Sealants Throughout** – It is suggested to seal all penetration with a stucco approved sealant at this time and every 2-3 years or as needed.

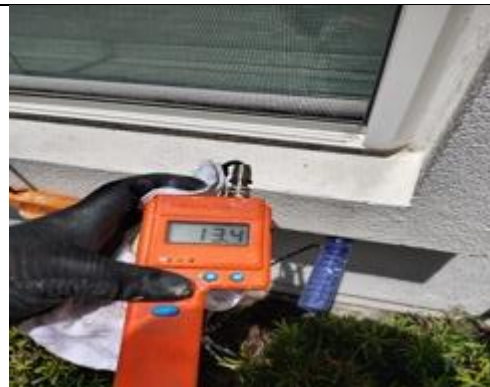
Low-mid moisture and firm substrate (possible framing taken below all front elevation windows at the probed locations at the time of inspection. This is a favorable/fair condition.

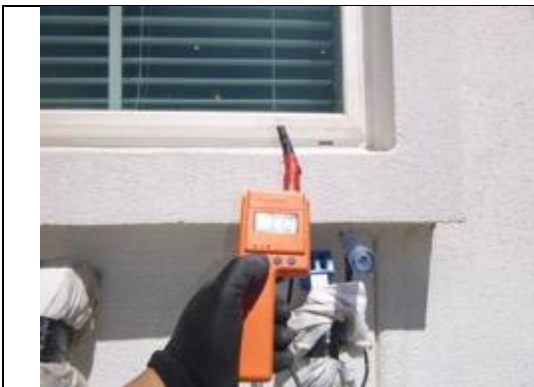
Low-mid moisture and firm substrate (possible framing taken below all front elevation windows at the probed locations at the time of inspection. This is a favorable/fair condition.

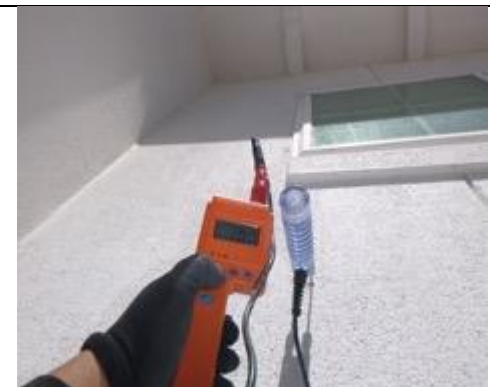
Low-mid moisture and firm substrate (possible framing taken below all front elevation windows at the probed locations at the time of inspection. This is a favorable/fair condition.

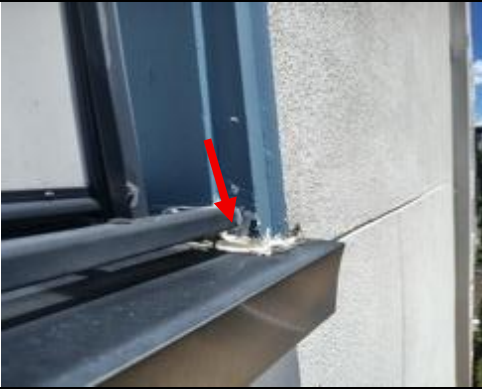
The door pan at the Juliet balcony door has been sealed. This is favorable. It is suggested to monitor and reseal every 2-3 years or as needed.

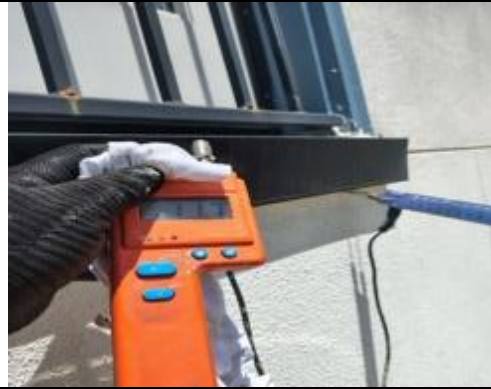
Low moisture and firm substrate (possible framing taken below the Juliet balcony at the probed locations at the time of inspection. This is a favorable condition.

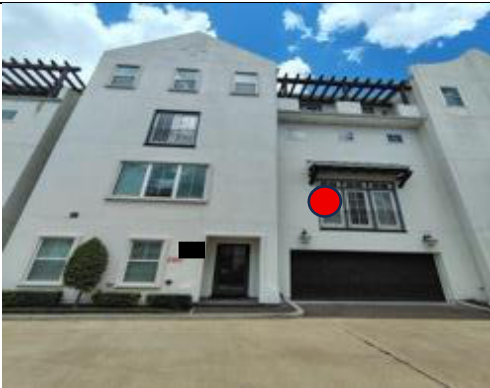
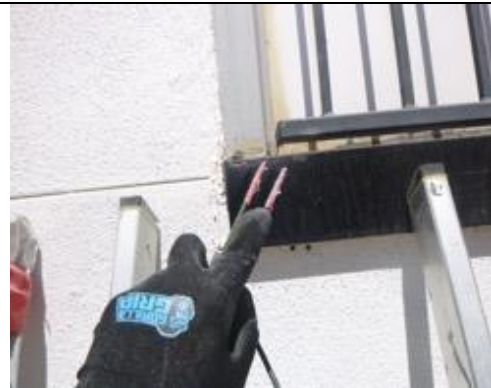
Probes penetrated approx 1 1/4" beyond the 3/4" stucco and elevated moisture. This is an indication of underlying damages (Noted as semi-soft) at probe 9 (below corner of Juliet balcony). It is suggested to further investigate the areas by opening a core sample to determine the source and extent of damages. See summary for suggested protocol.

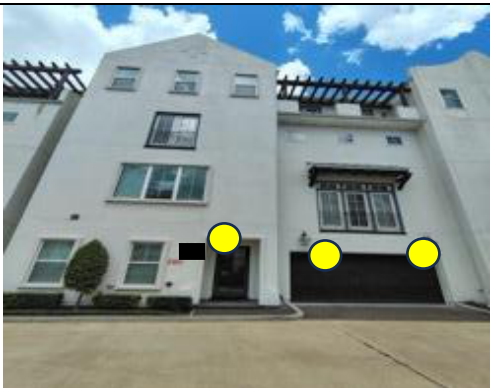
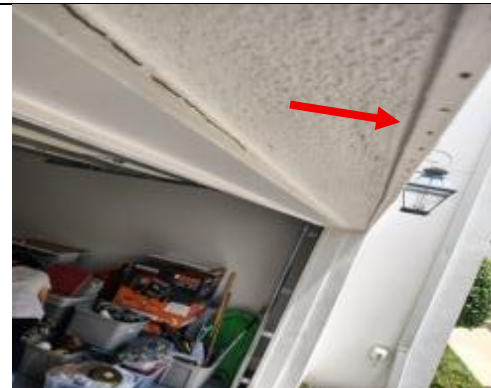
The overhang at the highlighted area terminates with a separated 66-casing. The perforations in the casing and drainage gap behind the casing are noted to have been painted/ clogged/ sealed closed. This can lead to trapped moisture and possible underlying issues. It is suggested to open all drainage planes and retrofit holes along the stucco casings, to allow for moisture relief.

**Overhangs** – The front overhangs terminate with a separated 66-casing. The perforations in the casing and drainage gap behind the casing are noted to have been painted/ clogged/ sealed closed. This can lead to trapped moisture and possible underlying issues. It is suggested to open all drainage planes and retrofit holes along the stucco casings, to allow for moisture relief. (No damages noted at time of inspection).

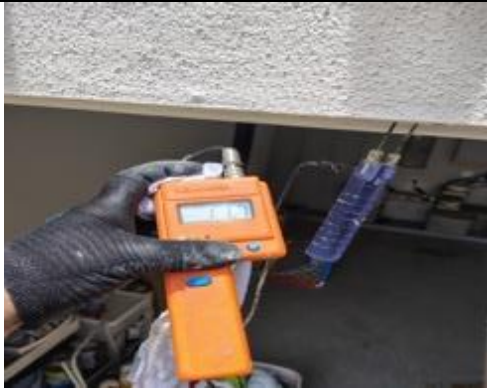
Low moisture and firm substrate (possible framing taken below the front elevation overhangs at the probed locations at the time of inspection. This is a favorable condition.

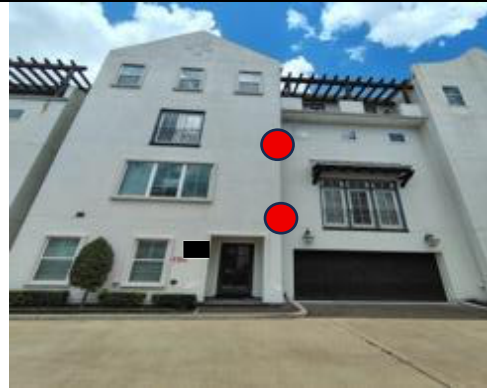
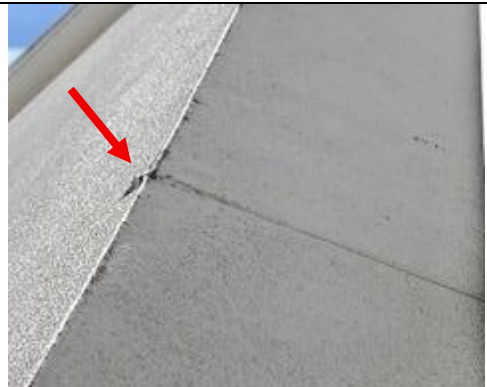
Cracking noted along the corner bead. This has led to moisture intrusion and underlying damages. It is suggested to repair accordingly.

**Cracking** – Hairline cracking noted on the left corner beads. Cracks are a common condition with stucco. Cracks can lead to moisture intrusion and possible underlying issues if not sealed, monitored, and maintained. It is suggested to seal all cracks with a stucco approved sealant at this time and as needed/ cracks develop. Elastomeric paint is also suggested to be applied every 5-10 years.

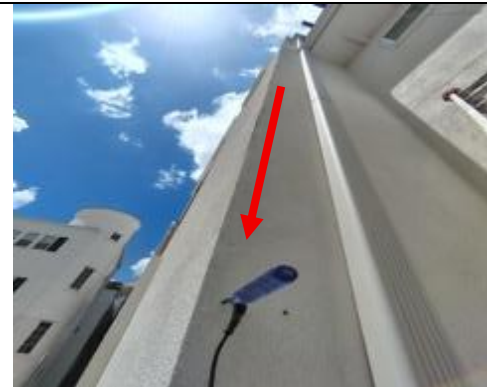
Soft substrate and possible framing (underlying damages) at probe locations 14-15. It is suggested to open a core sample to further investigate the source and extent of damages. Once exposed, damages may extend beyond the tested location. See summary for suggested protocol.

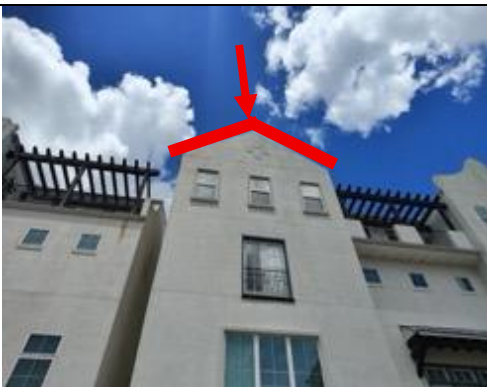
A missing cap flashing noted at the roofing parapet wall. Other deficiencies may be occurring behind the highlighted location. This condition can lead to moisture intrusion and underlying damages. It is suggested to repair any known or found damages and install a cap flashing at all locations noted with this deficiency.

**Roofing Wall** – A missing cap flashing noted at the roofing parapet wall. Other deficiencies may be occurring behind the highlighted location. This condition can lead to moisture intrusion and underlying damages. It is suggested to repair any known or found damages and install a cap flashing at all locations noted with this deficiency.

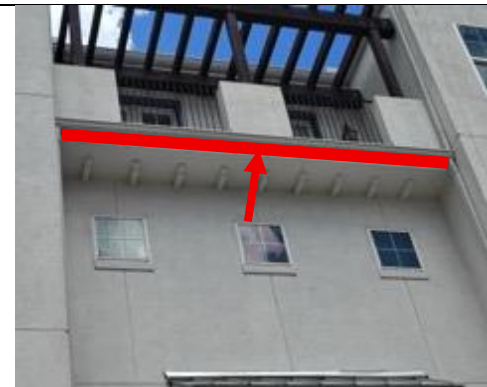
The overhang at the highlighted area terminates with a separated 66-casing. The soffit is noted to be siding. The perforations in the casing and drainage gap behind the casing are noted to have been painted/ clogged/ sealed closed. This can lead to trapped moisture and possible underlying issues. Staining found at the time of inspection. It is suggested to open all drainage planes and retrofit holes along the stucco casings, to allow for moisture relief.

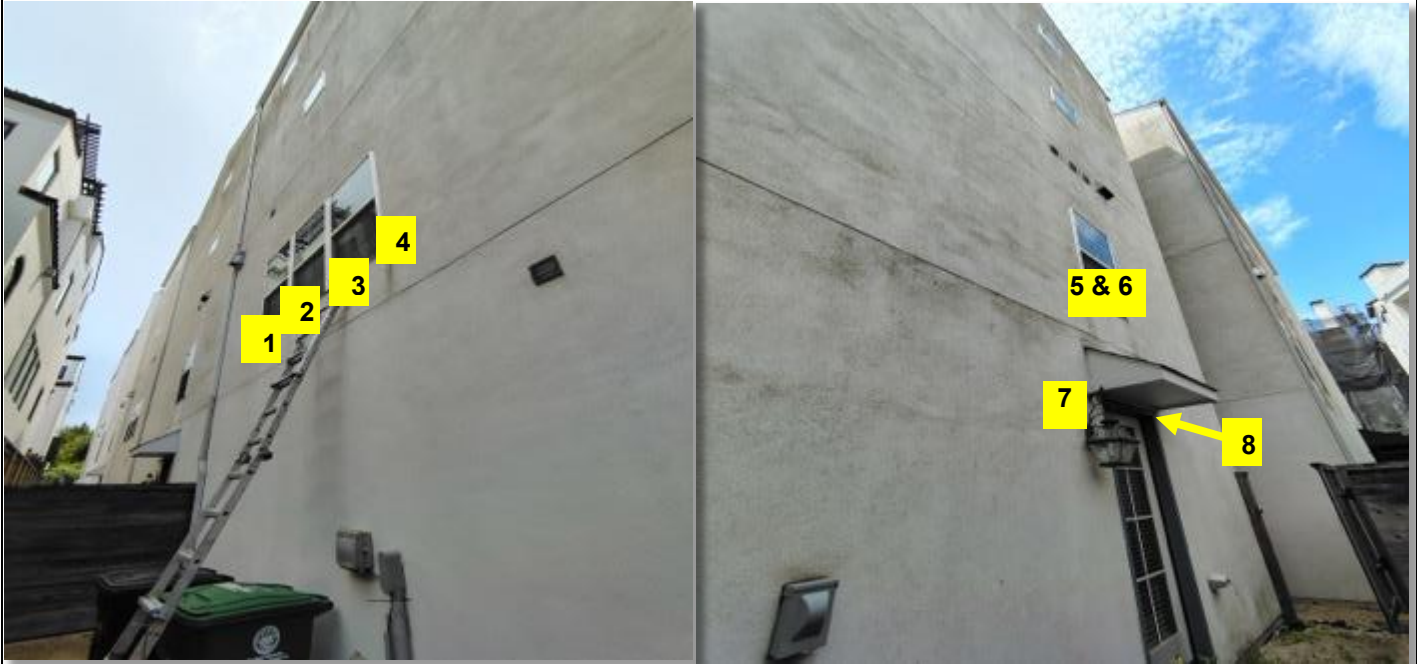
### Rear Elevation Moisture Analysis

| Location | Moisture Reading | Substrate Condition | Comments |
|---|---|---|---|
| 1 | 13% | Firm | Probes 1-6 taken below the front elevation windows.<br><br>Firm substrate/framing and Low-mid moisture noted at the probed locations at the at the time of inspection. This is a favorable/fair condition. |
| 7 | 14% | Firm | Probes 7-8 taken below the corners of the small roof junctions. |
| 8 | 10% | Firm | Firm substrate/framing and Low moisture noted at the probed locations at the at the time of inspection. This is a favorable condition. |

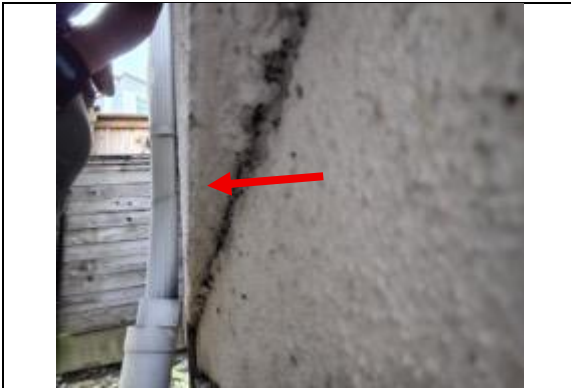
The stucco walls terminate with a weep screed flush with the foundation with little to no clearance or drainage gap. This can lead to trapped moisture and underlying damages. (No apparent issues found at the time of inspection.) All terminations should have a weep screed with a proper 2-4-inch clearance from grade or any paved areas). See the balconies form example.

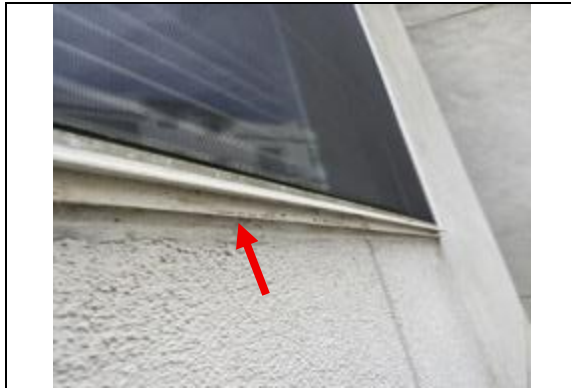
The sealant application that was previously done has reached/exceeded their life expectancy. It is suggested to remove the existing sealants and replace/ reseal all windows, accent bands, cracks, flashings, and penetrations at this time and, routinely, every 2-3 years.

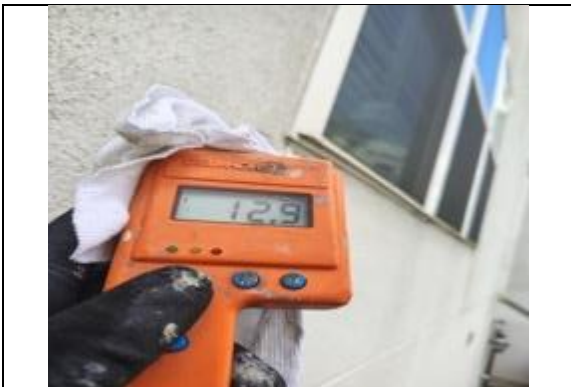
Low-mid moisture and firm substrate (possible framing) taken below the rear elevation windows at probe locations at the time of inspection. This is a favorable/fair condition.

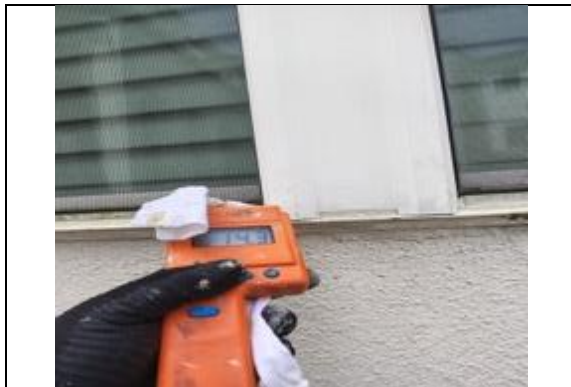
Low-mid moisture and firm substrate (possible framing) taken below the rear elevation windows at probe locations at the time of inspection. This is a favorable/fair condition.

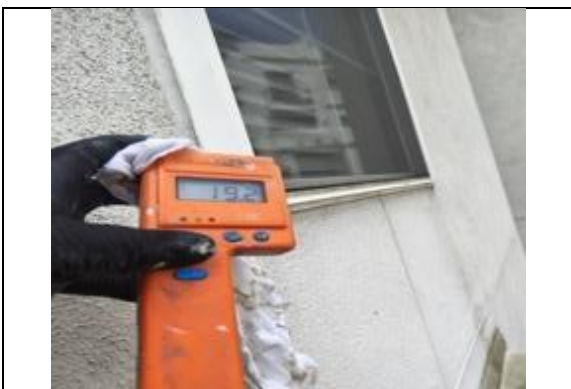
Low-mid moisture and firm substrate (possible framing) taken below the rear elevation windows at probe locations at the time of inspection. This is a favorable/fair condition.

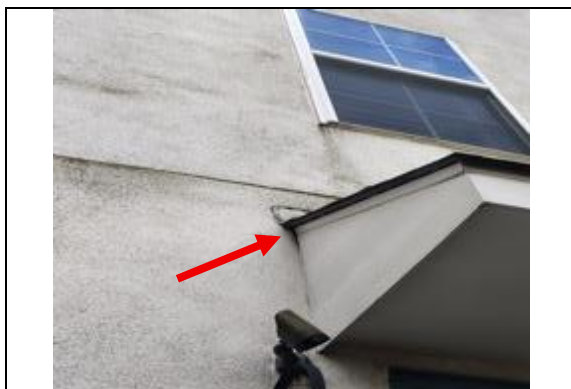
It is suggested to seal all roof junctions with a stucco approved sealant every 2-3 years or as needed.

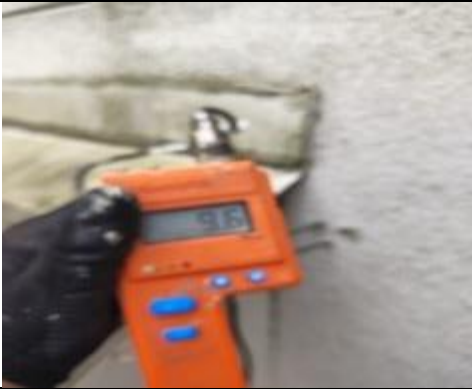
Low moisture and firm substrate (possible framing) taken below the corners of the small roof junction at probe locations at the time of inspection. This is a favorable condition.

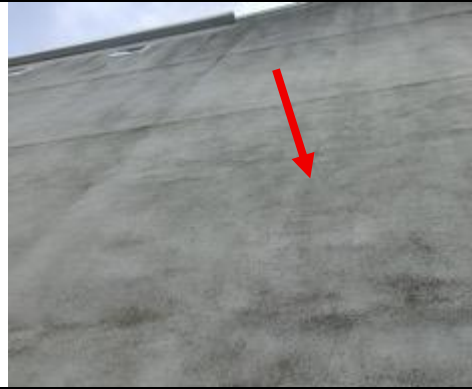
Surface staining noted throughout. This is a common condition with stucco. It is suggested to use a light power wash with a solvent based solution to help remedy this condition. It is also recommended to repaint the home with an elastomeric paint every 5-10 years.

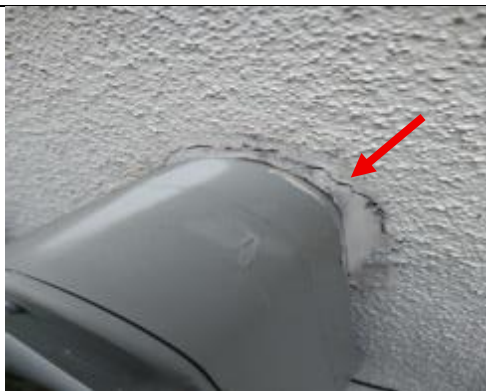
The sealant application that was previously done has reached/exceeded their life expectancy. It is suggested to remove the existing sealants and replace/ reseal all windows, accent bands, cracks, flashings, and penetrations at this time and, routinely, every 2-3 years.

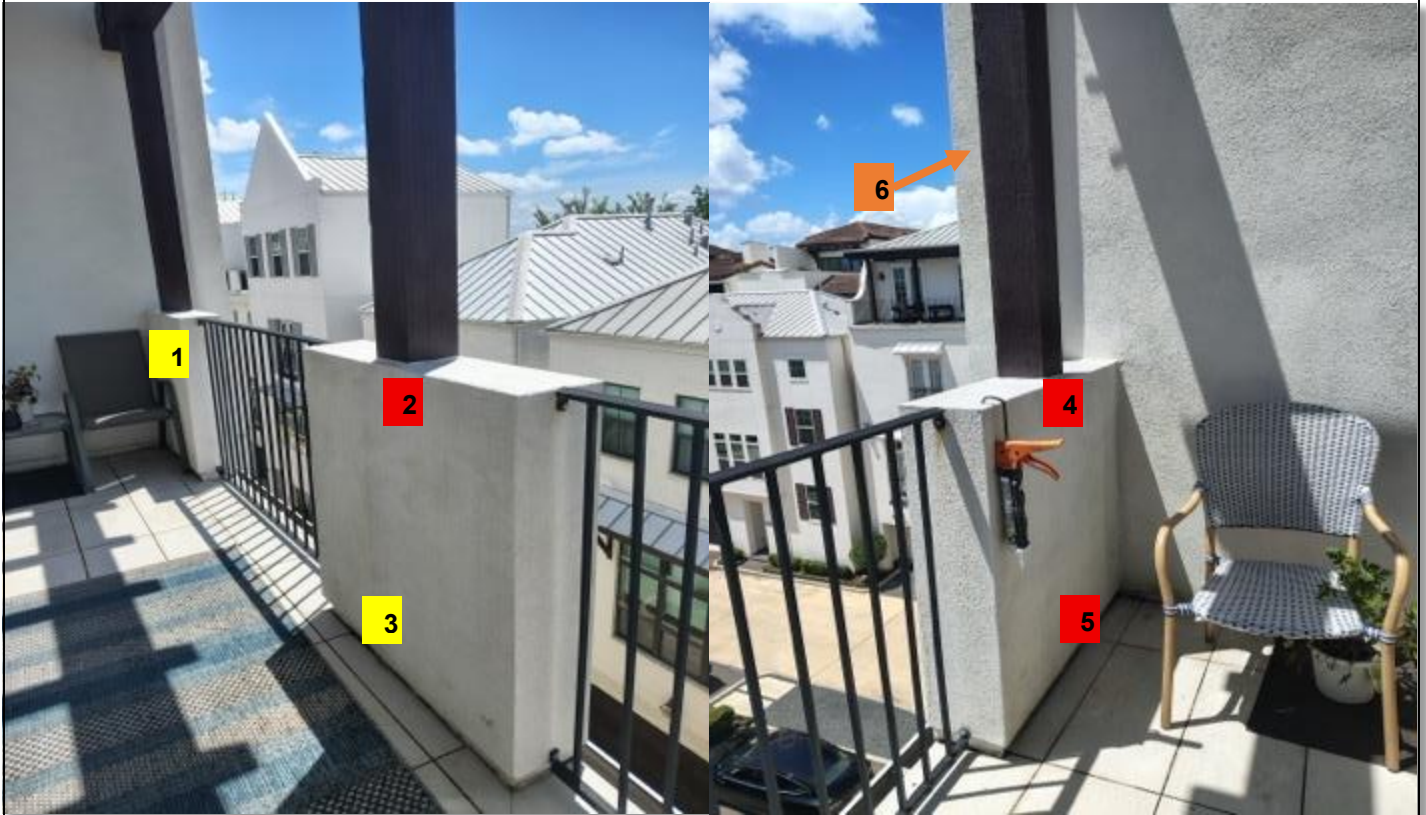
### Balcony Elevation Moisture Analysis

| Location | Moisture Reading | Substrate Condition | Comments |
|---|---|---|---|
| 1 | 9% | Firm | Probes 1-5 taken below the balcony parapet wall.<br><br>Probes penetrated approx 1 ¼" beyond the ¾" stucco and elevated moisture. This is an indication of underlying damages (Noted as semi-soft) at probes 2, 4-5. It is suggested to further investigate the areas by opening a core sample to determine the source and extent of damages. See summary for suggested protocol.<br><br>Firm substrate/framing and Low moisture noted at the remaining probed locations at the at the time of inspection. This is a favorable condition. |
| 6 | 33% | Firm | Probe 6 taken below the roof-to-stucco junction/roofing parapet wall.<br><br>Elevated moisture and firm substrate (possible framing) taken below the roof-to-stucco junction, at the probed location, at the time of inspection. It is suggested to further investigate and install a cap flashing at the roofing parapet wall. |
| 7 | 9% | Firm | Probes 7-8 taken below the rear elevation windows.<br><br>Firm substrate/framing and Low moisture noted at the probed locations at the at the time of inspection. This is a favorable condition. |

- **Balcony Parapet Wall– Further Investigation Recommended:** Soft substrate and possible framing (underlying damages) at left probe locations 2, 4 and 5. It is suggested to open a core sample to further investigate the source and extent of damages. Once exposed, damages may extend beyond the tested location. See summary for suggested protocol.

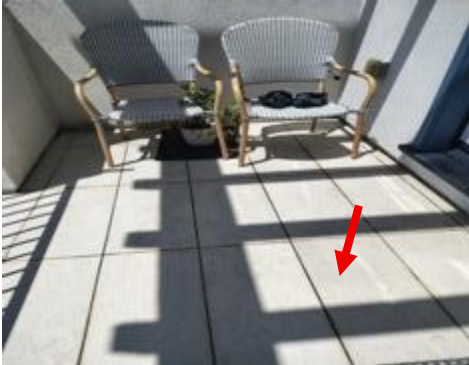
Standing water noted on the balcony flooring tiles. This is due to a lack of pitch. This can lead to underlying issues. It is suggested to consult a stucco contractor to for any balcony repairs.

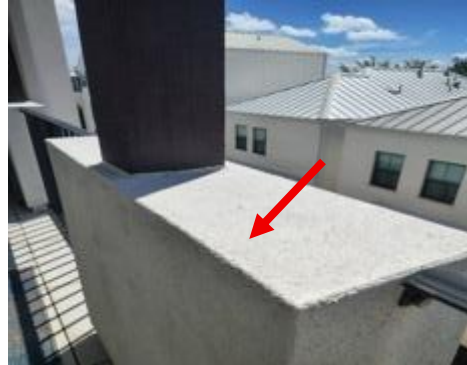
Missing cap flashings noted at the balcony parapet walls. Previously sealed cracks throughout. These conditions can lead to moisture intrusion and possible underlying issues. It is suggested to repair all known/found damages and install cap flashings at all locations noted with this deficiency.

**Balcony Parapet Wall** – Missing cap flashings noted at the balcony parapet walls. Previously sealed cracks throughout. These conditions can lead to moisture intrusion and possible underlying issues. It is suggested to repair all known/found damages and install cap flashings at all locations noted with this deficiency.

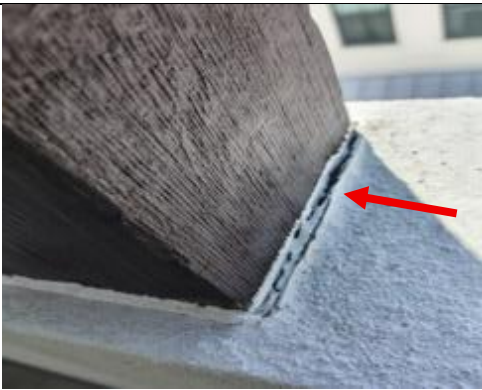
Openings noted around the pergola attachment. If this attachment isn't waterproofed properly these conditions can lead to moisture intrusion and underlying damages. It is suggested to repair all known/found damages and install cap flashings to help prevent future issues.

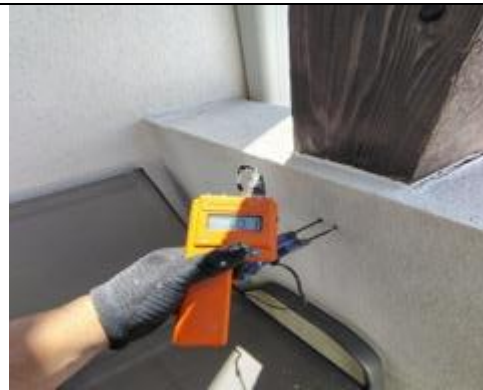
Missing and or cut short kickout flashings at the corners of the front balcony. This can lead to moisture intrusion and underlying damages. To help prevent future issues it is recommended to install properly sized and angled flashings at all locations noted with this deficiency.

**Balcony Kickouts-** Missing kickout flashings at the corners of the front balcony (Top balcony). This can lead to moisture intrusion and underlying damages. To help prevent future issues it is recommended to install properly sized and angled flashings at all locations noted with this deficiency.

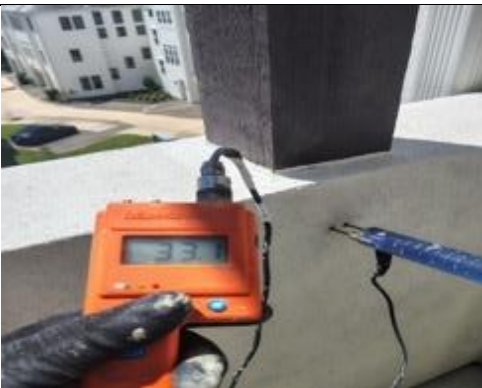
Probes penetrated approx 1 1/4" beyond the 3/4" stucco and elevated moisture. This is an indication of underlying damages (Noted as semi-soft) at probes 2, 4-5. It is usggested to further investigate the areas by opening a core sample to determine the source and extent of damages. See summary for suggested protocol.

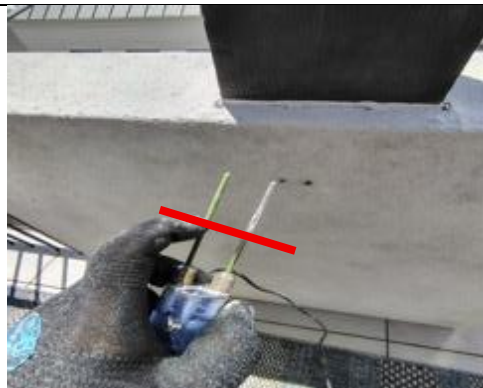
Probes penetrated approx 1 1/4" beyond the 3/4" stucco and elevated moisture. This is an indication of underlying damages (Noted as semi-soft) at probes 2, 4-5. It is usggested to further investigate the areas by opening a core sample to determine the source and extent of damages. See summary for suggested protocol.

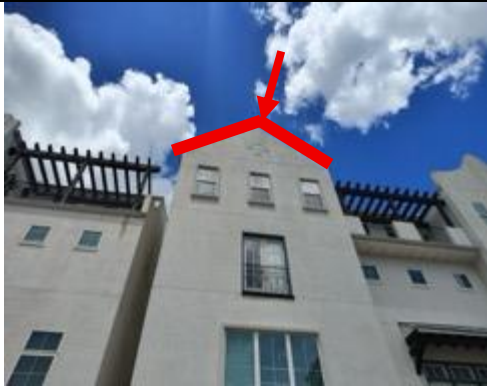
A missing cap flashing noted at the roofing parapet wall. Other deficiencies may be occurring behind the highlighted location. This condition can lead to moisture intrusion and underlying damages. It is suggested to repair any known or found damages and install a cap flashing at all locations noted with this deficiency.

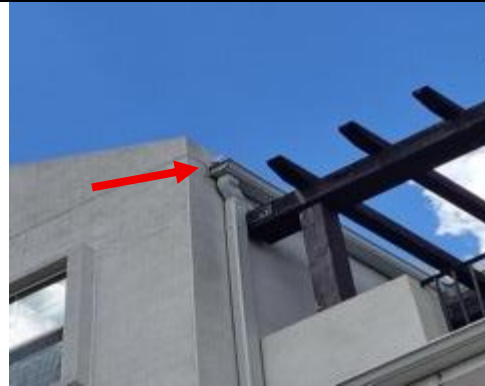
Cracking noted at the roof-to-stucco junction. The inspector believes there's an overflow of water or leak at this location. It is suggested to further investigate and address/repair accordingly.

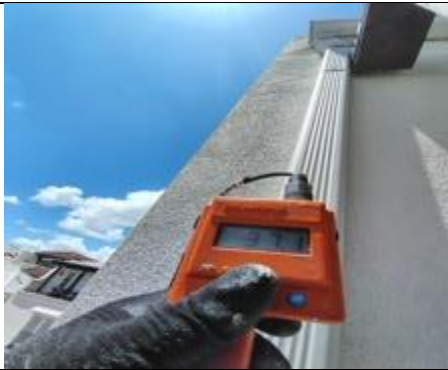
Elevated moisture and firm substrate (possible framing) taken below the roof-to-stucco junction, at the probed location, at the time of inspection. It is suggested to further investigate and install a cap flashing at the roofing parapet wall.

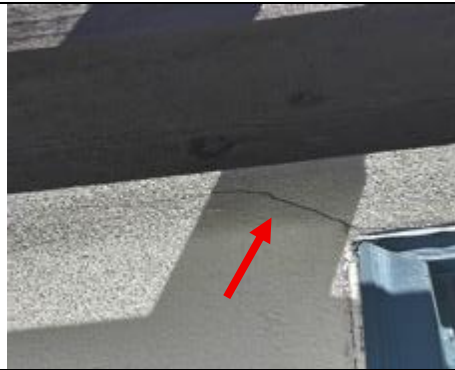
Hairline cracking noted in various locations, throughout. Cracks are a common condition with stucco. Cracks can lead to moisture intrusion and possible underlying issues if not sealed, monitored, and maintained. It is suggested to seal all cracks with a stucco approved sealant at this time and as needed/ cracks develop. Elastomeric paint is also suggested to be applied every 5-10 years.

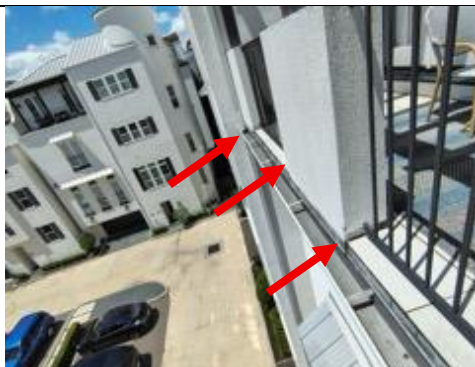
Missing kickout flashings at the corners of the front balcony. This can lead to moisture intrusion and underlying damages. To help prevent future issues it is recommended to install properly sized and angled flashings at all locations noted with this deficiency.
